Building Control Officers Perspective

IBCI Building Control Conference 2019

27th March 2019

Most Common Construction Defects Observed by Cork City Council

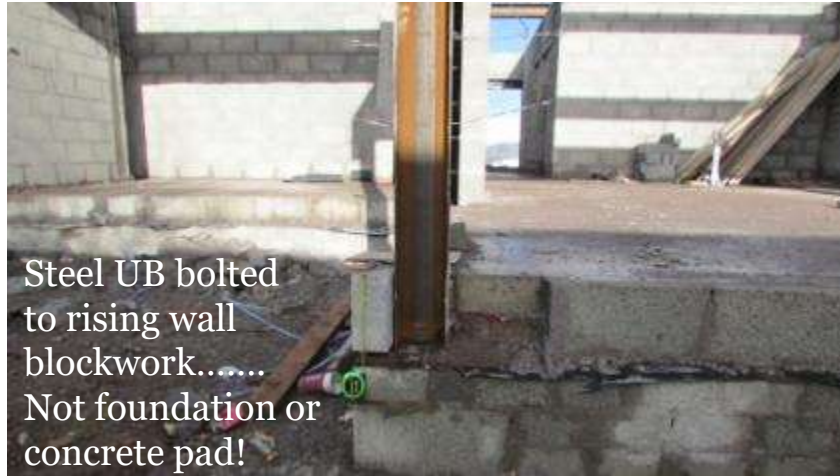
Steel UB bolted to rising wall blockwork.....
Not foundation or concrete pad!

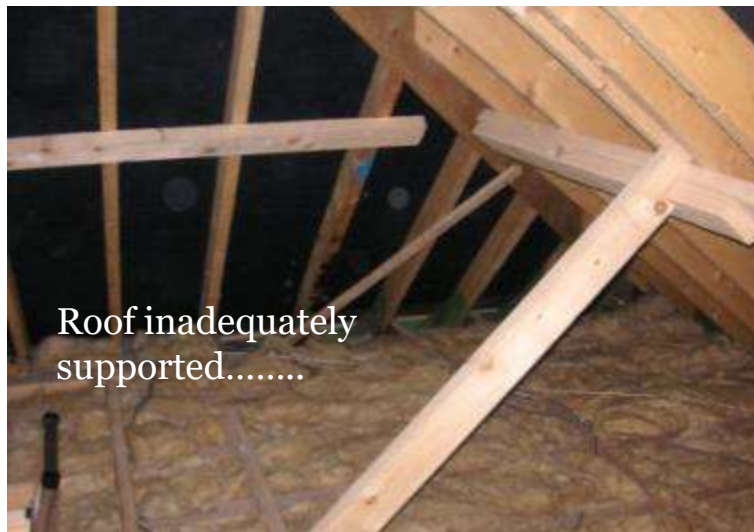
Roof inadequately supported.....

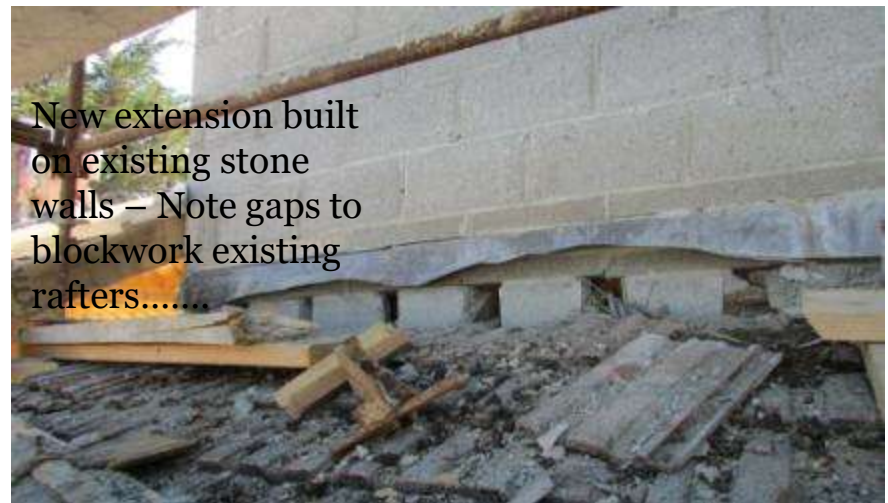
New extension built on existing stone walls – Note gaps to blockwork existing rafters.....

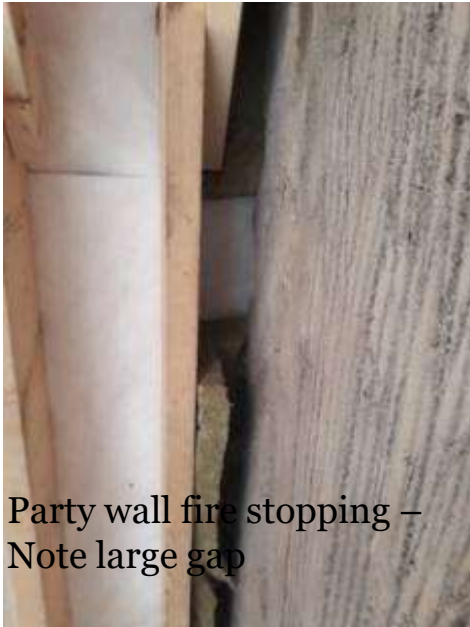
Party wall fire stopping –
Note large gap

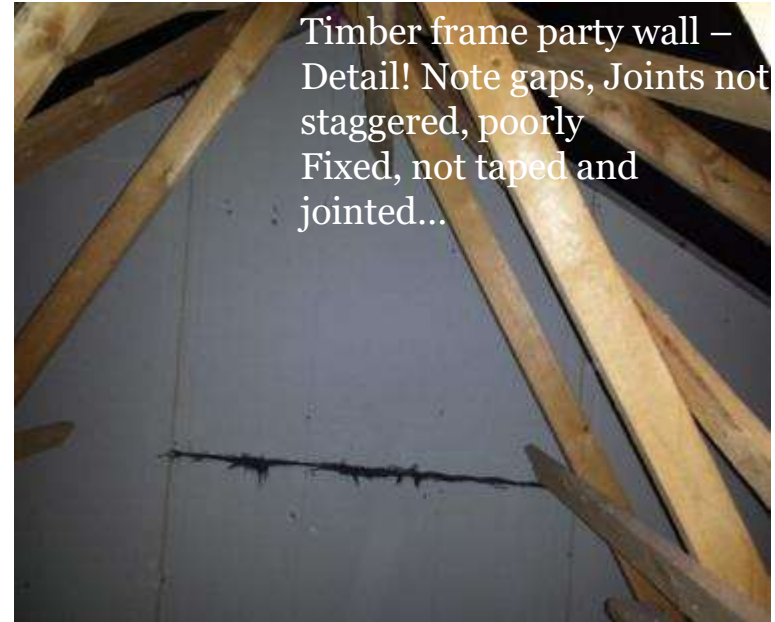
Timber frame party wall –
Detail! Note gaps, Joints not
staggered, poorly
Fixed, not taped and
jointed...

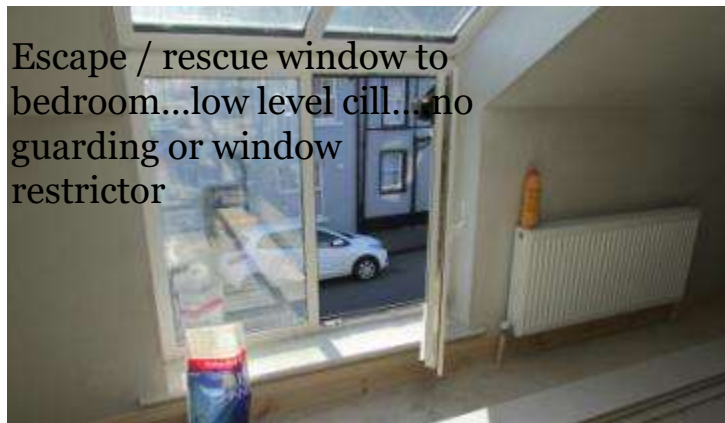
Escape / rescue window to
bedroom...low level sill...no
guarding or window
restrictor

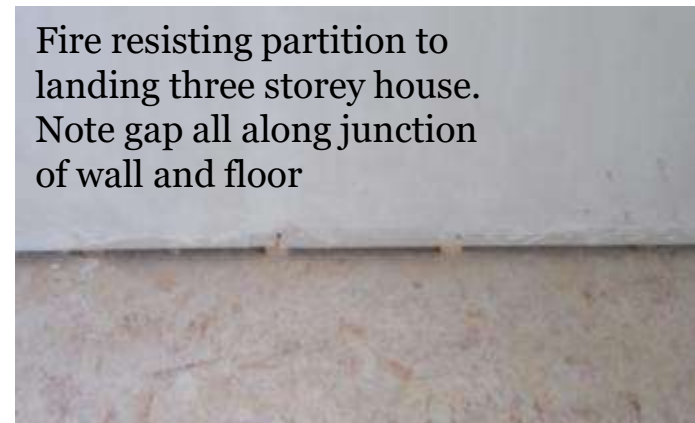
Fire resisting partition to
landing three storey house.
Note gap all along junction
of wall and floor

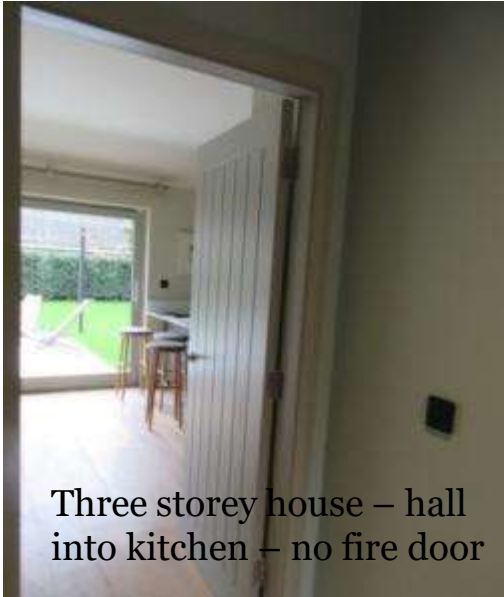
Three storey house – hall into kitchen – no fire door

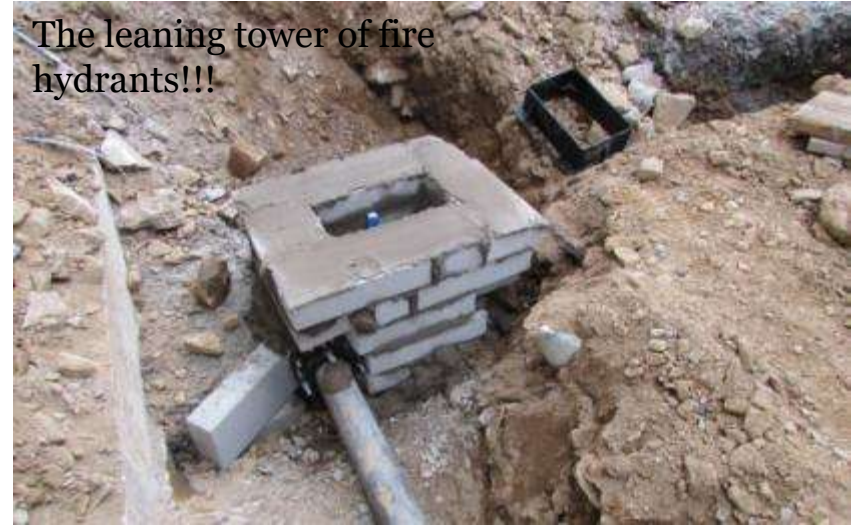
The leaning tower of fire hydrants!!!

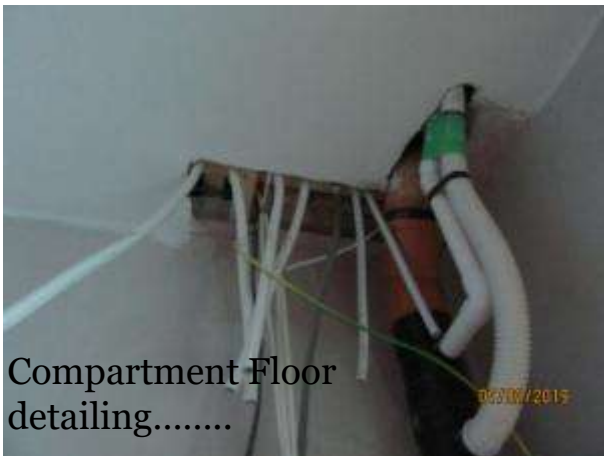
Compartment Floor detailing.....

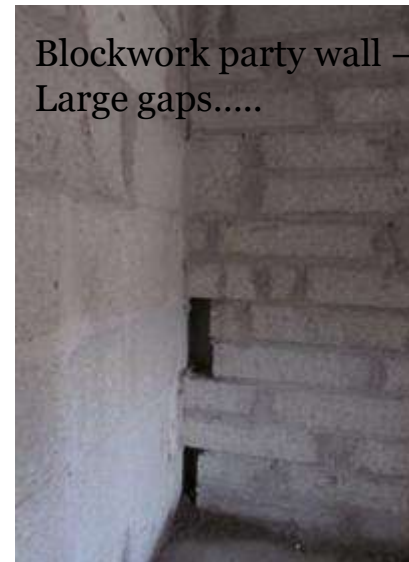
Blockwork party wall – Large gaps.....

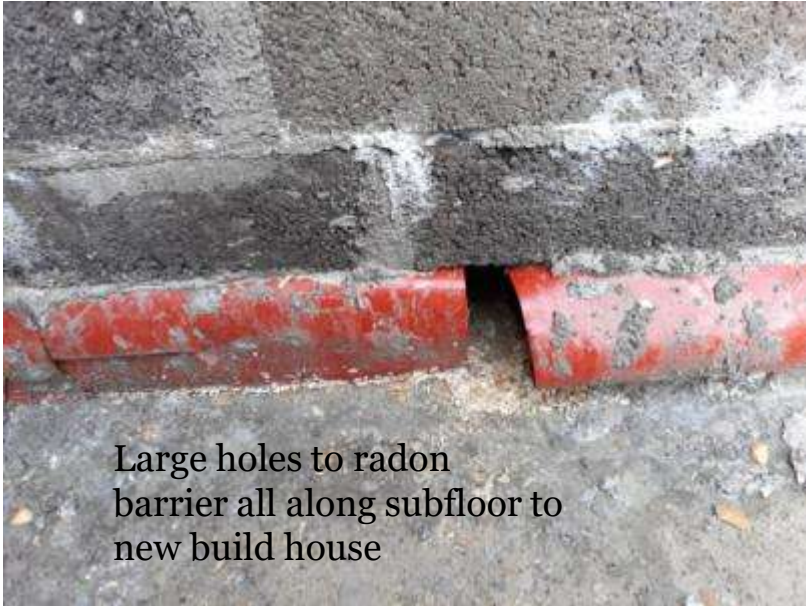
Large holes to radon barrier all along subfloor to new build house

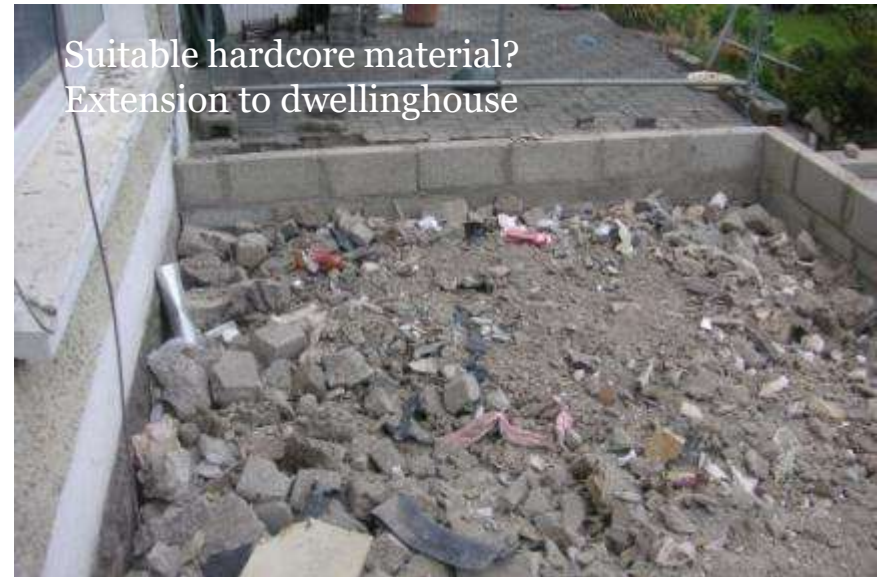
Suitable hardcore material?
Extension to dwellinghouse

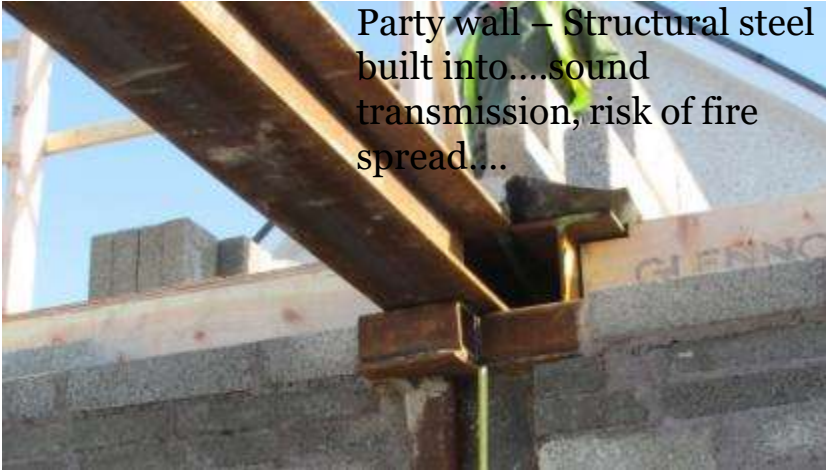
Party wall – Structural steel built into....sound transmission, risk of fire spread....

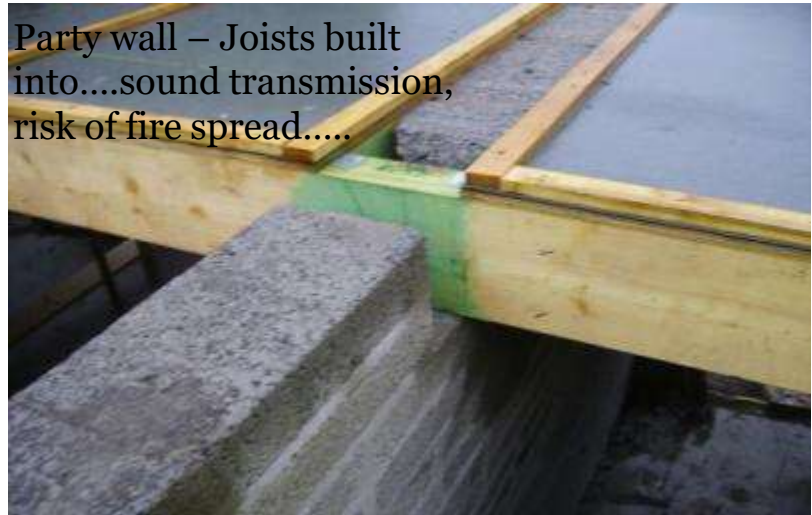
Party wall – Joists built into....sound transmission, risk of fire spread.....

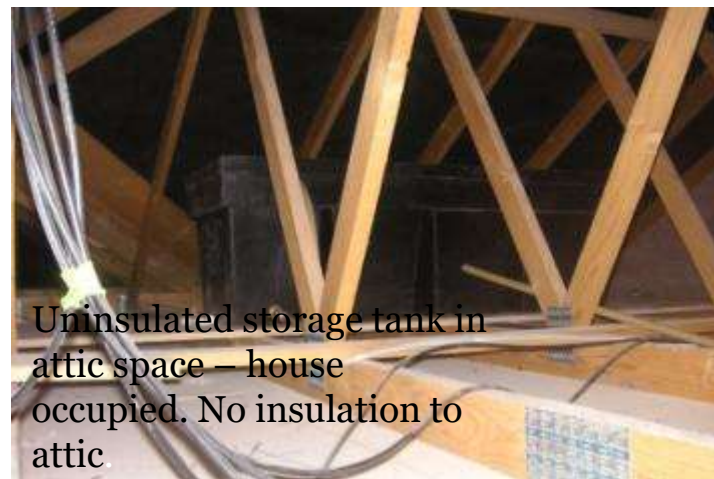
Uninsulated storage tank in attic space – house occupied. No insulation to attic

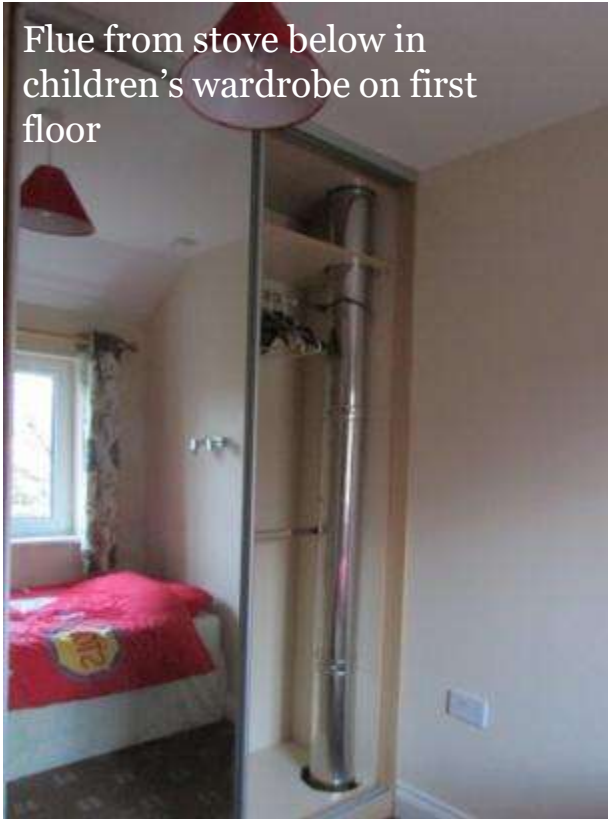
Flue from stove below in children's wardrobe on first floor

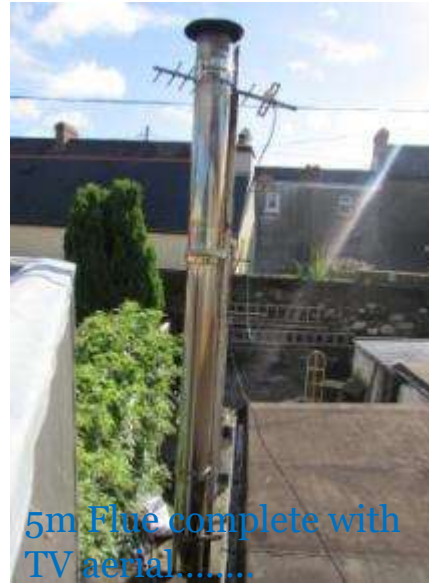
5m Flue complete with TV aerial.....

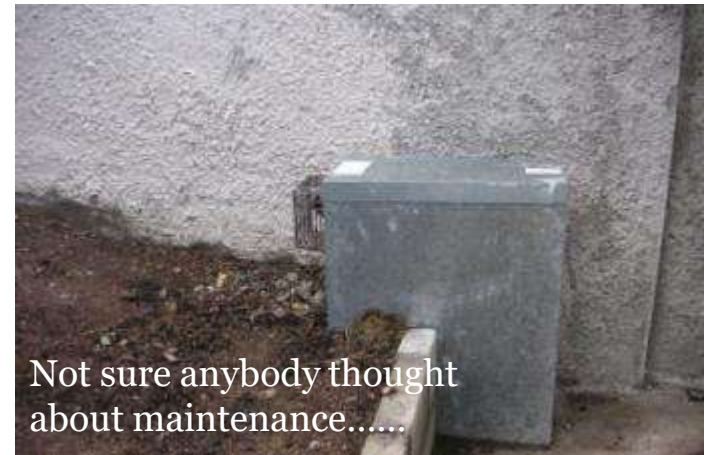
Not sure anybody thought about maintenance.....

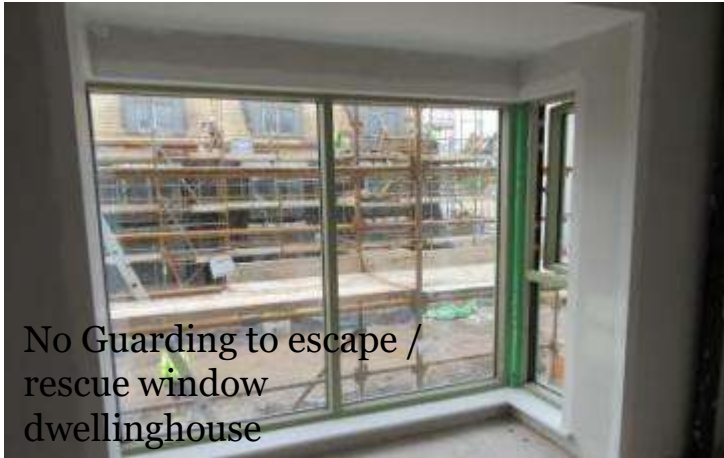
No Guarding to escape /
rescue window
dwellinghouse

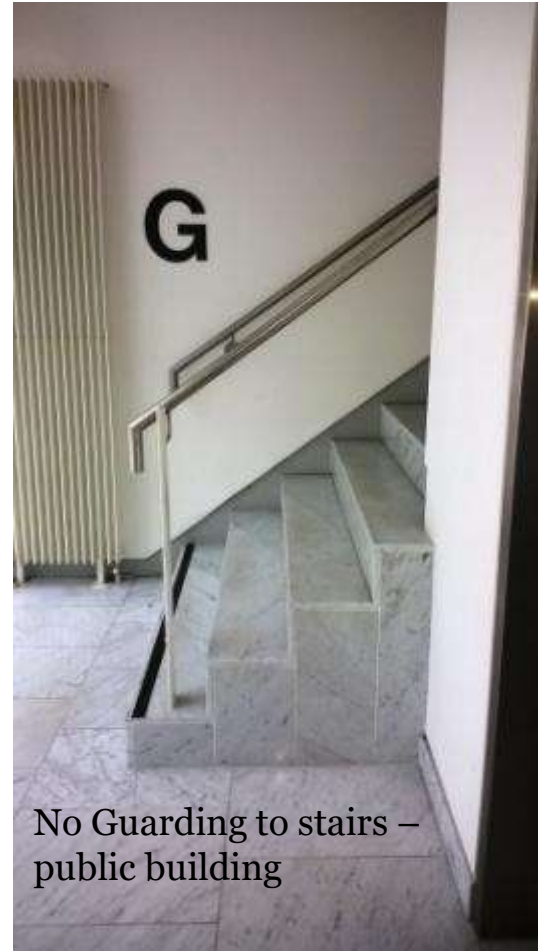
No Guarding to stairs –
public building

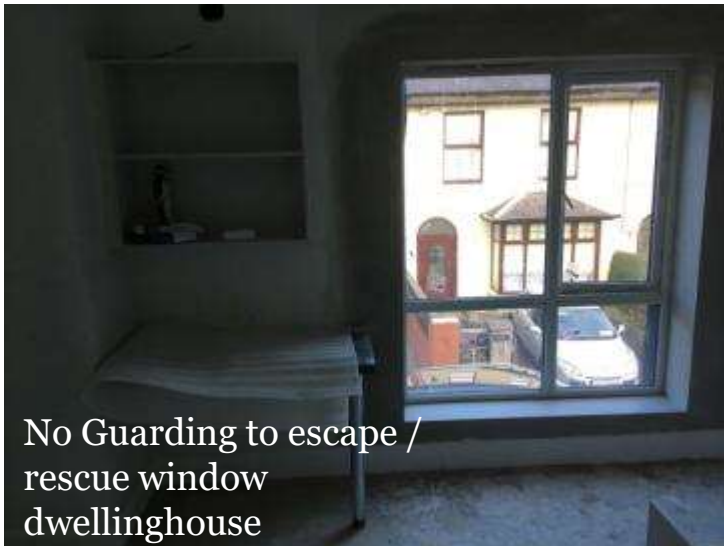
No Guarding to escape /
rescue window
dwellinghouse

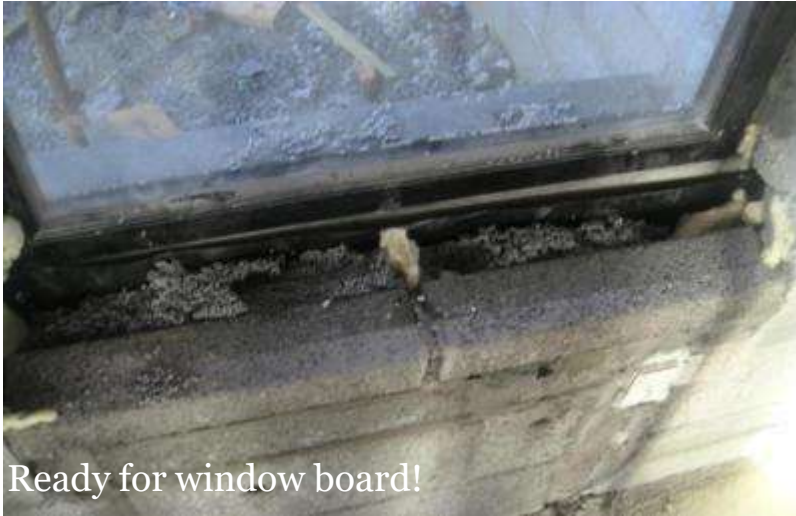
Ready for window board!

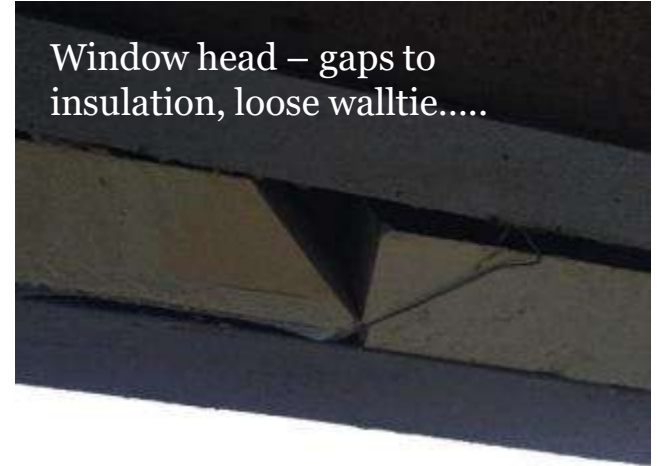
Window head – gaps to insulation, loose walltie....

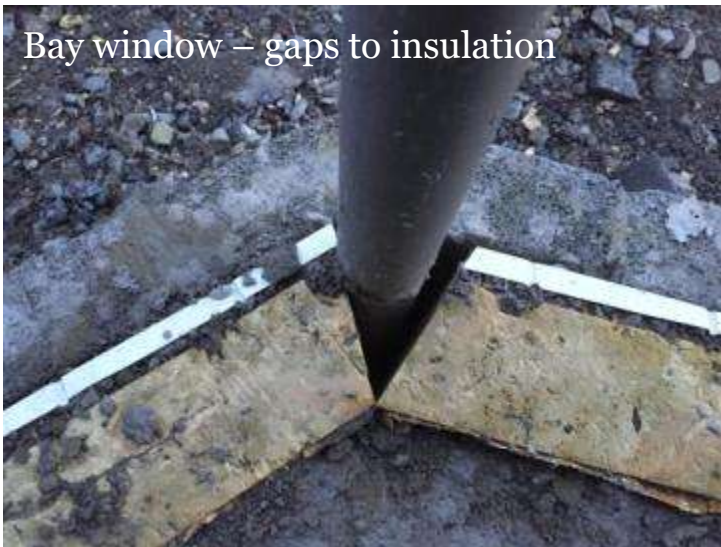
Bay window – gaps to insulation

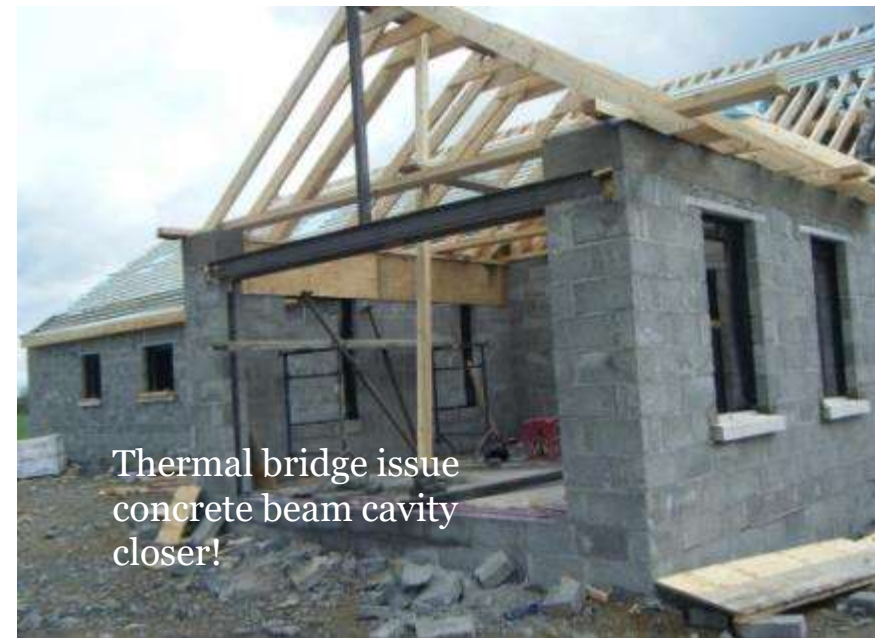
Thermal bridge issue
concrete beam cavity
closer!

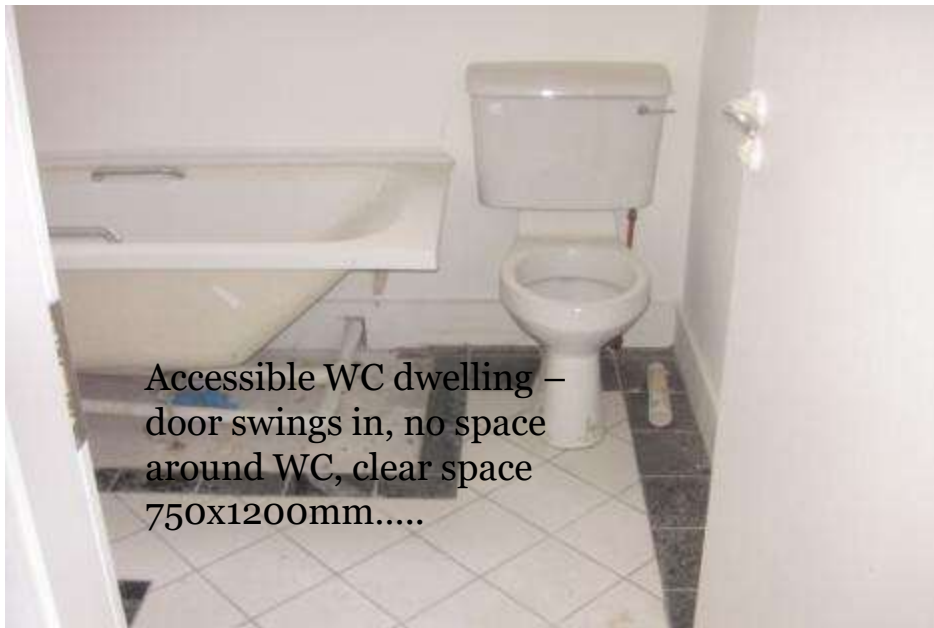
Accessible WC dwelling –
door swings in, no space
around WC, clear space
750x1200mm.....

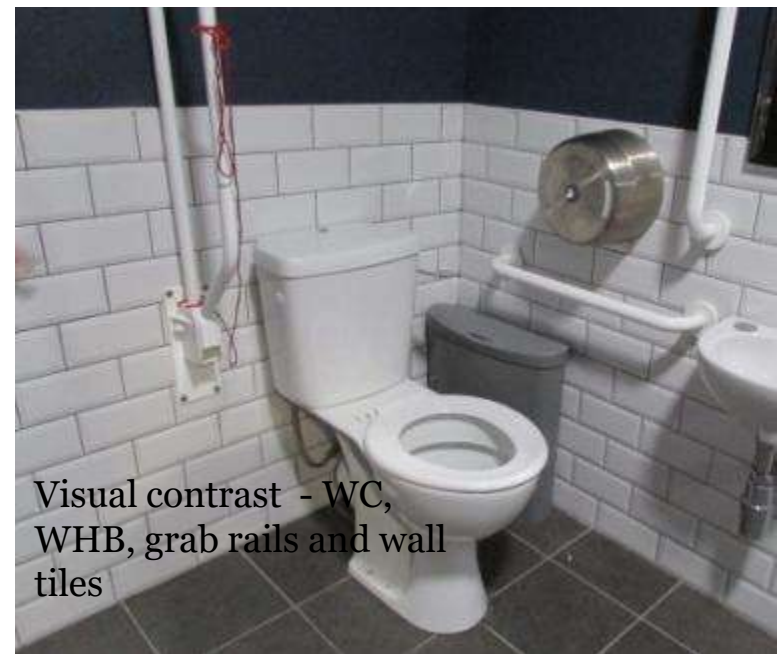
Visual contrast - WC,
WHB, grab rails and wall
tiles
