SOUND INSULATION TESTING IN DWELLINGS

Chris Dilworth, AWN Consulting

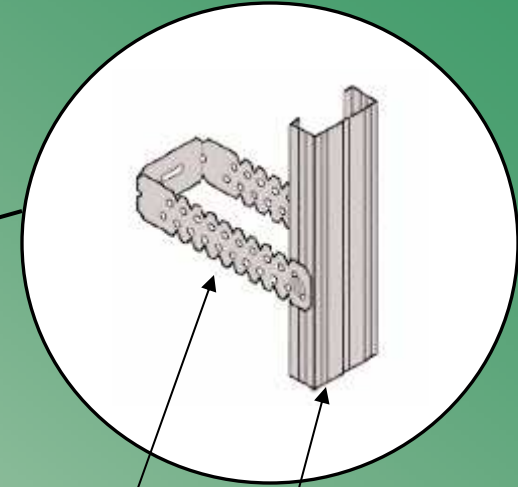
Metal Straps

Metal "U" Channel

- One alternative fixing method we have tested recently employs a metal “U” channel which is restrained to the wall using metal straps.
- Plasterboard is attached to the “U” channel and the metal strap is adjustable to give cavity depths of 30mm to 100mm.
- Sound insulation performance in excess of 60dB $D_{nT,w}$ has been measured with this system.

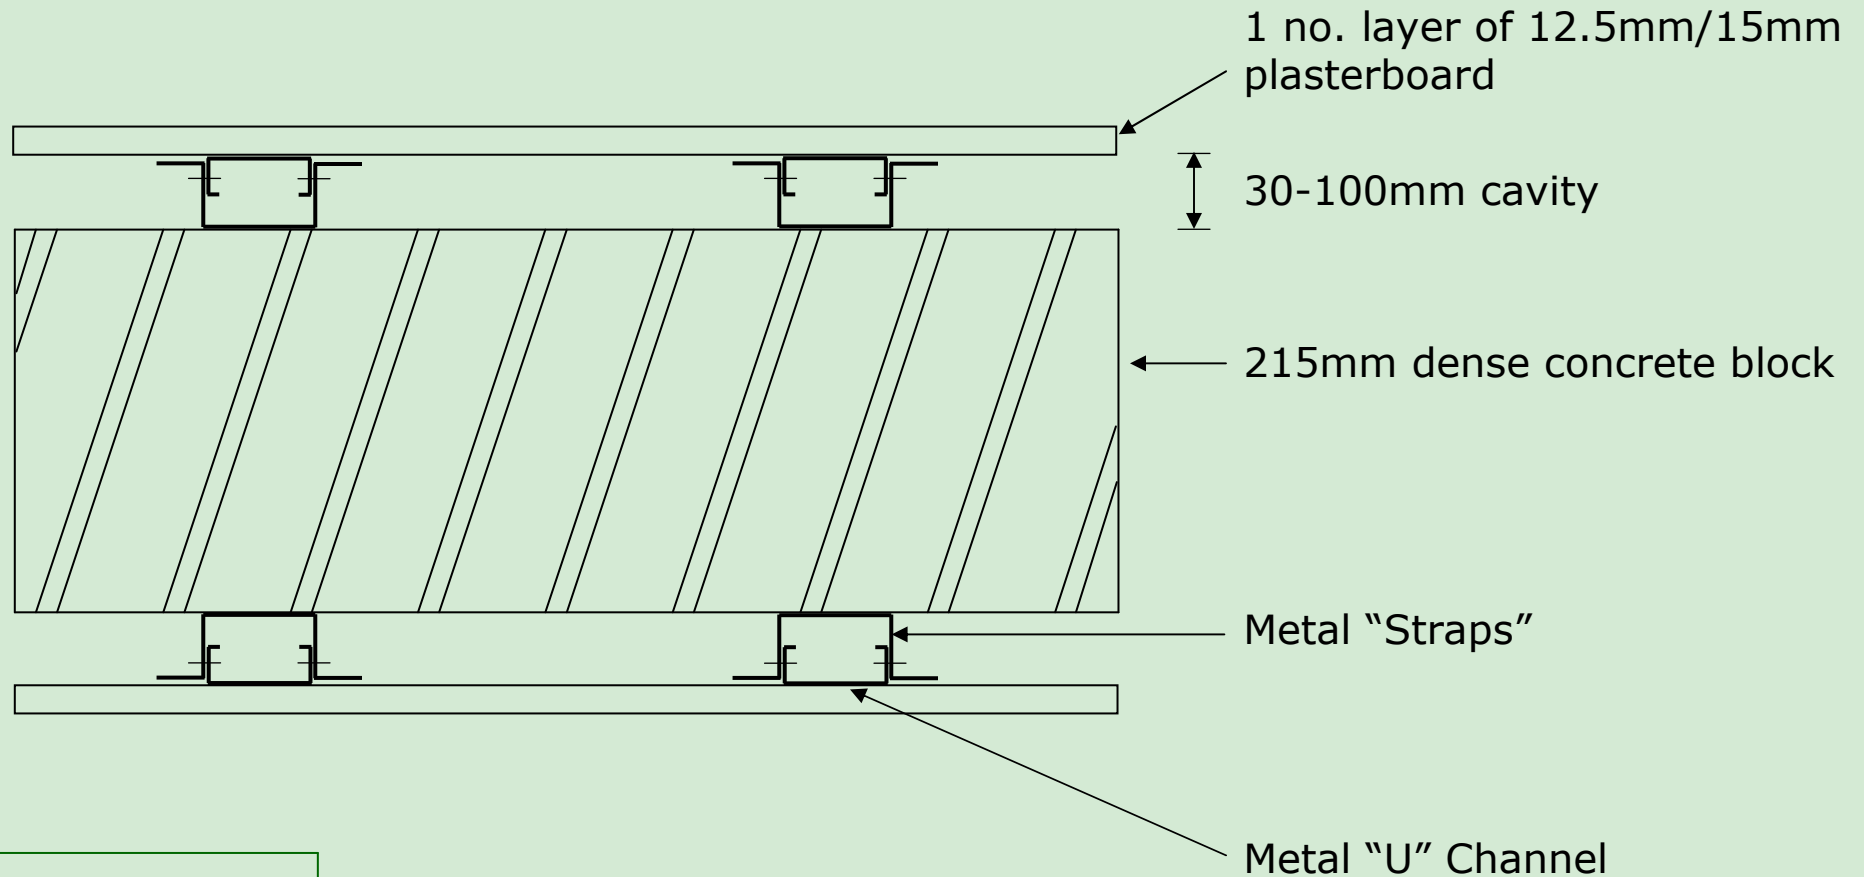
Compare with Plasterboard on Dabs

- Installing plasterboard using alternative fixing methods can offer significant improvements.
- When compared to plasterboard on dabs, it reduces/eliminates the mid to high frequency “dip”.
- The results presented here represent the upper end of what is achievable.
- We have also observed a reduction in the mid to high frequency “dip” when standard metal “top-hat” sections are used to attach the plasterboard.
- This type of construction also provides good structure-borne isolation, i.e. “clicking” light switches and sockets.
- The **low-frequency** performance of the wall can be reduced.

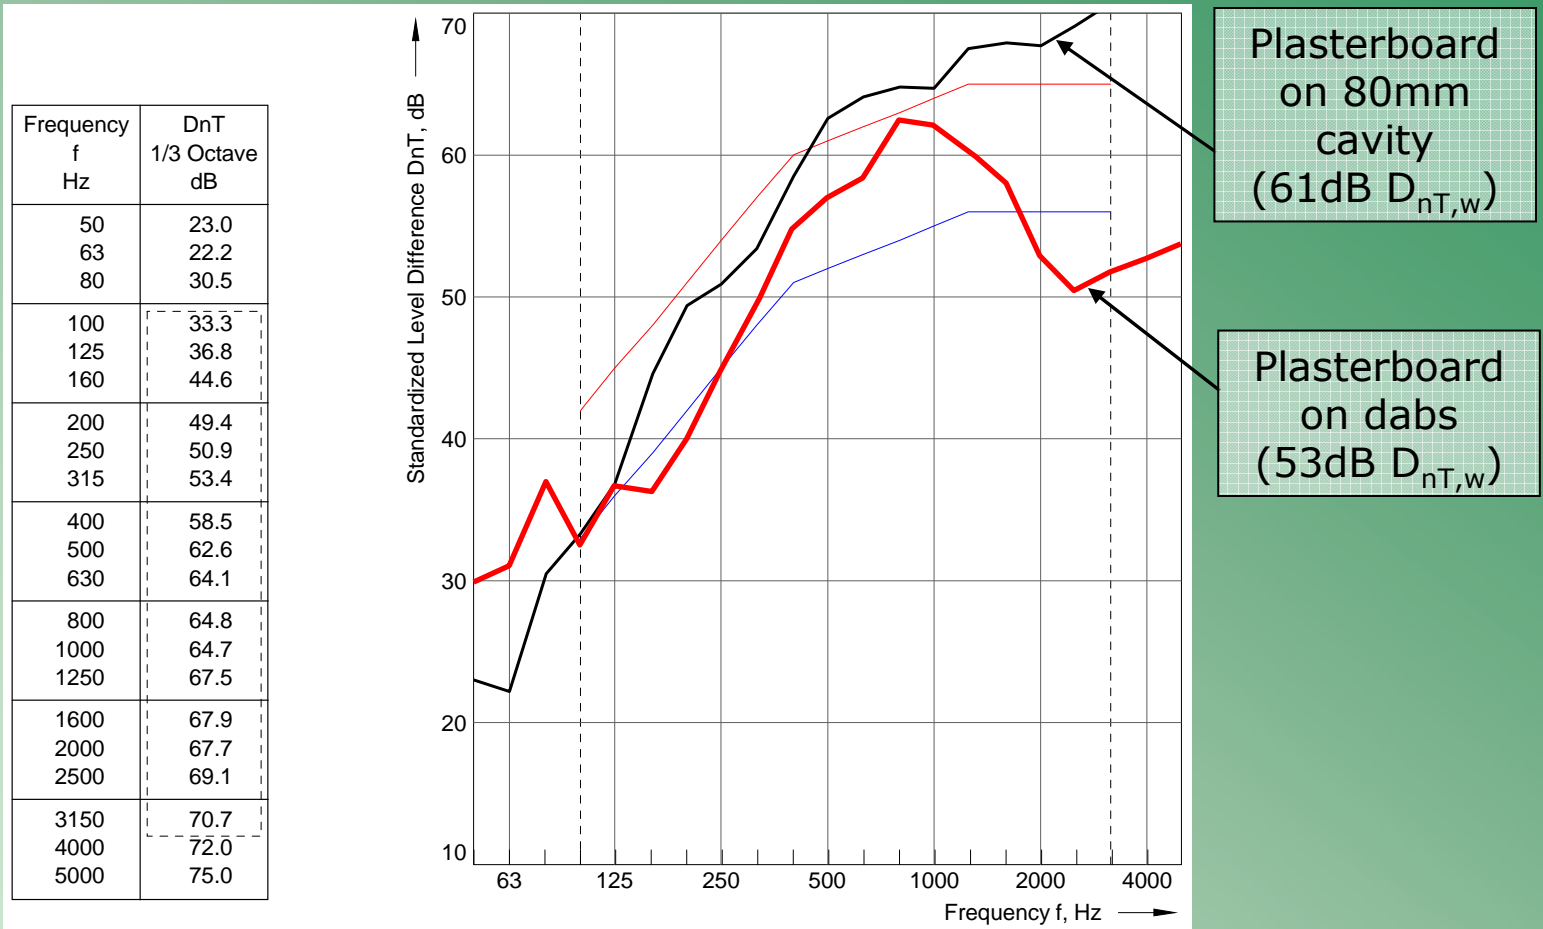
Typical sound insulation spectrum

- Attaching plasterboard to concrete block walls using dabs, typically results in a “dip” in sound insulation at **mid to high frequencies**.
- Attaching plasterboard to concrete block walls using metal channels offers better overall performance but can result in a “dip” in sound insulation at **low-frequencies** (this effect can be minimised by large cavity depths).
- Using a traditional render finish does not result in either of the two negative effects noted above.

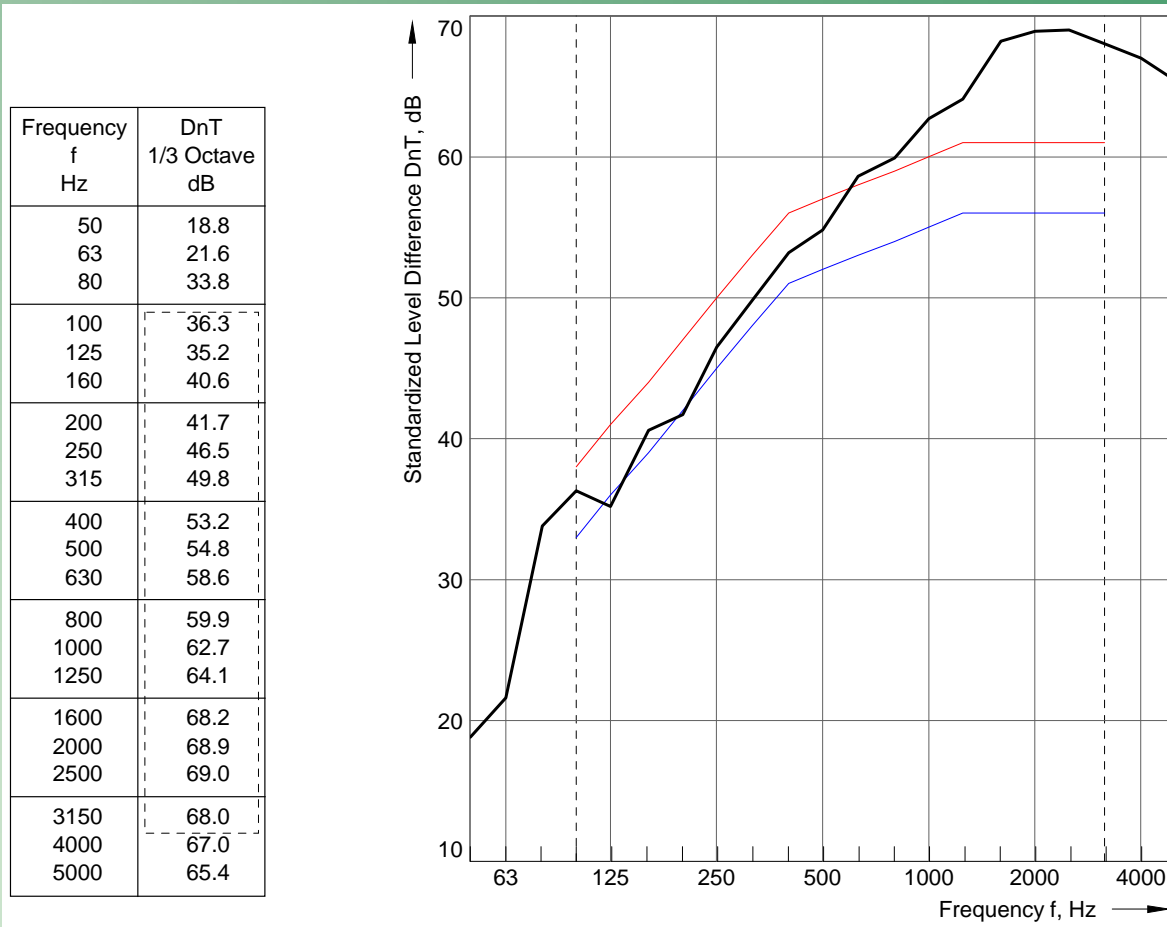
Typical sound insulation spectrum

Single figure index: 57dB $D_{nT,w}$

- Average airborne sound insulation performance 61.7dB $D_{nT,w}$
- None of the constructions tested gave results <53 dB $D_{nT,w}$
- A typical sound insulation spectrum exhibits an upward trend from low to high frequency, with nothing significant by way of “dips”.
- The measured values ranged from 56 to 69dB $D_{nT,w}$.

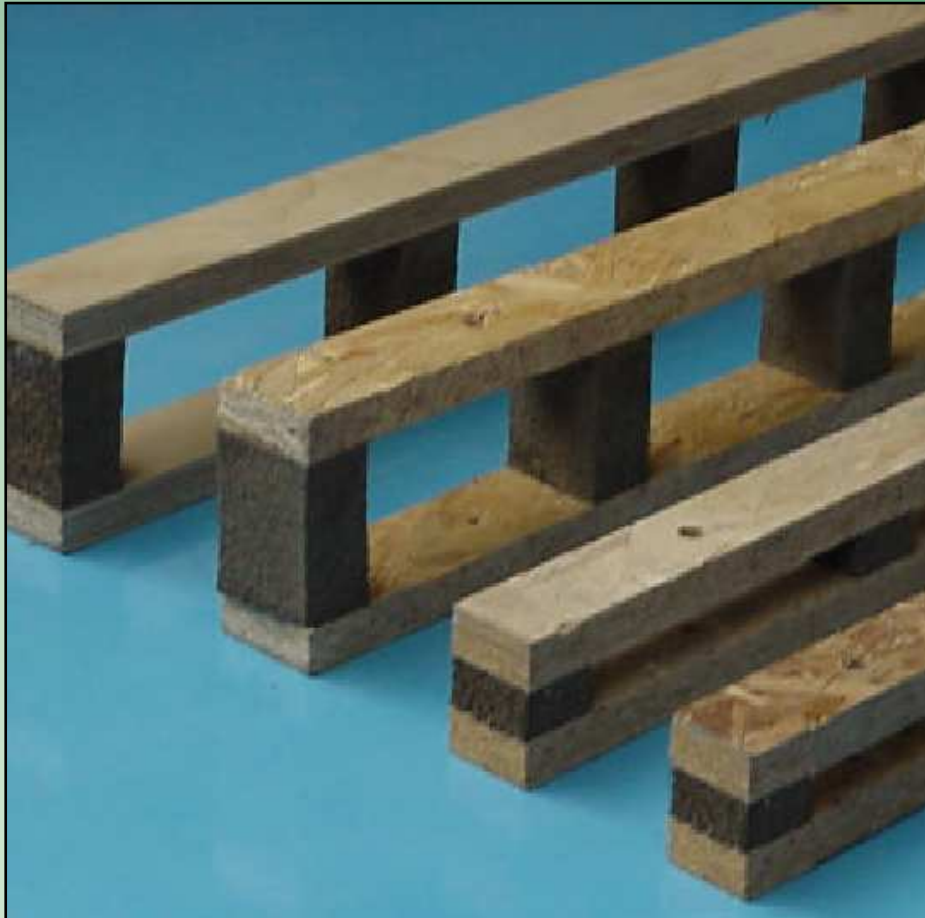
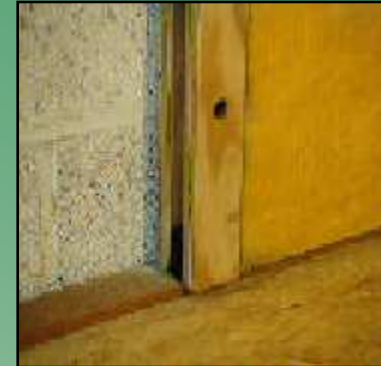
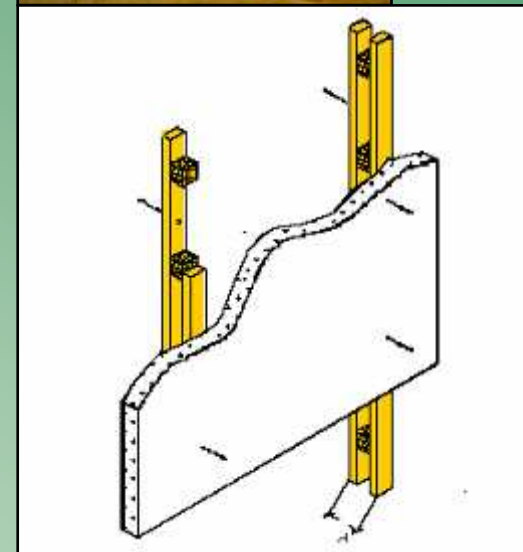
Proprietary isolating battens

- Suitable wall linings to be applied to one side of the wall must offer both **mass** and **isolation**.
- **Mass** is provided by using two layers of 15mm plasterboard.
- **Isolation** is provided by installing the plasterboard on an independent stud system or proprietary isolating “battens”.

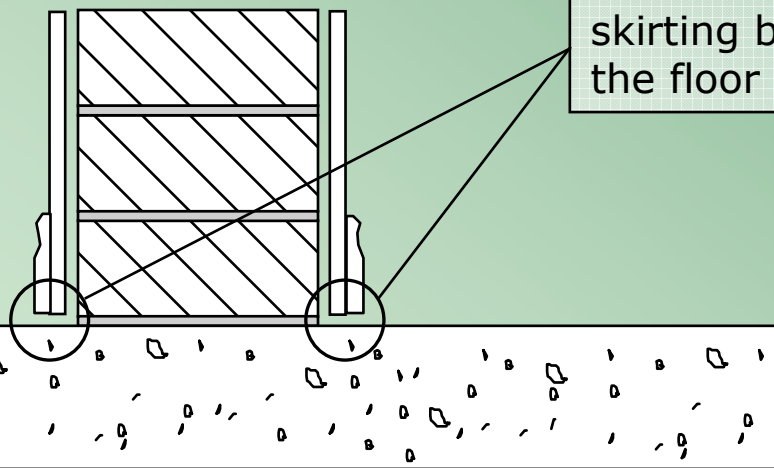
Plasterboard wall lining and skirting board **not** sealed to the floor slab

- The sealing of junctions between party walls and the surrounding structural elements can have a significant effect on the measured sound insulation performance.
- The most common acoustic weakness witnessed during testing is at the junction between the party wall and the underside of the floor/ceiling structure above.
- Some party walls are also affected by leakage at the base of the wall.

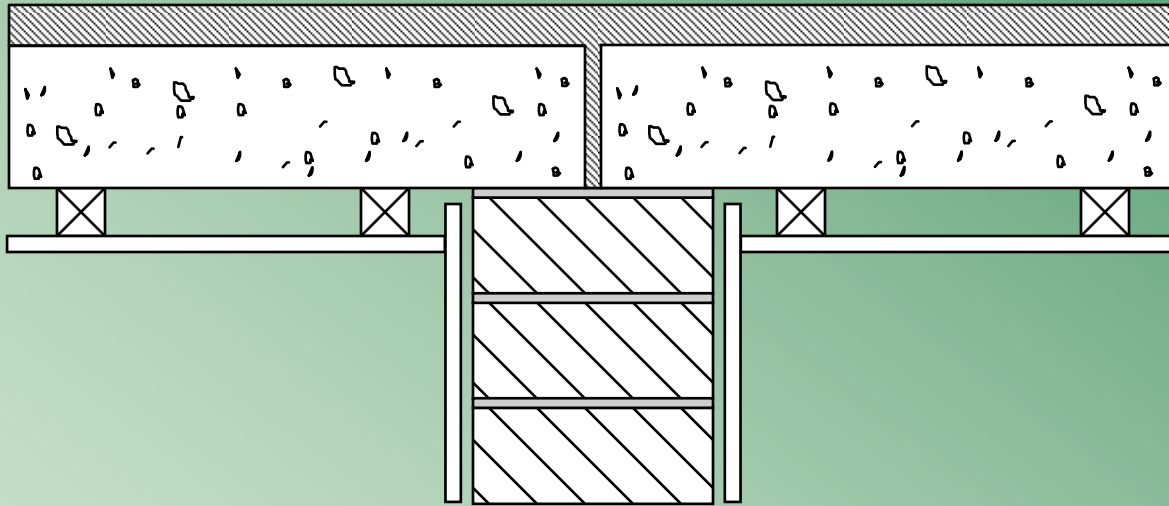
Extend plasterboard to ~5mm from the floor slab and apply acoustic sealant

- It is recommended that acoustic sealant is applied to the full perimeter of plasterboard lining to party walls.
- This reduces noise transfer via the ceiling cavity and at floor level.
- This simple treatment can provide a noticeable increase in the sound insulation performance of party walls.
